Investigation into the flooding in Wainfleet in June 2019

Version: FINAL

Issued: 7th February 2020

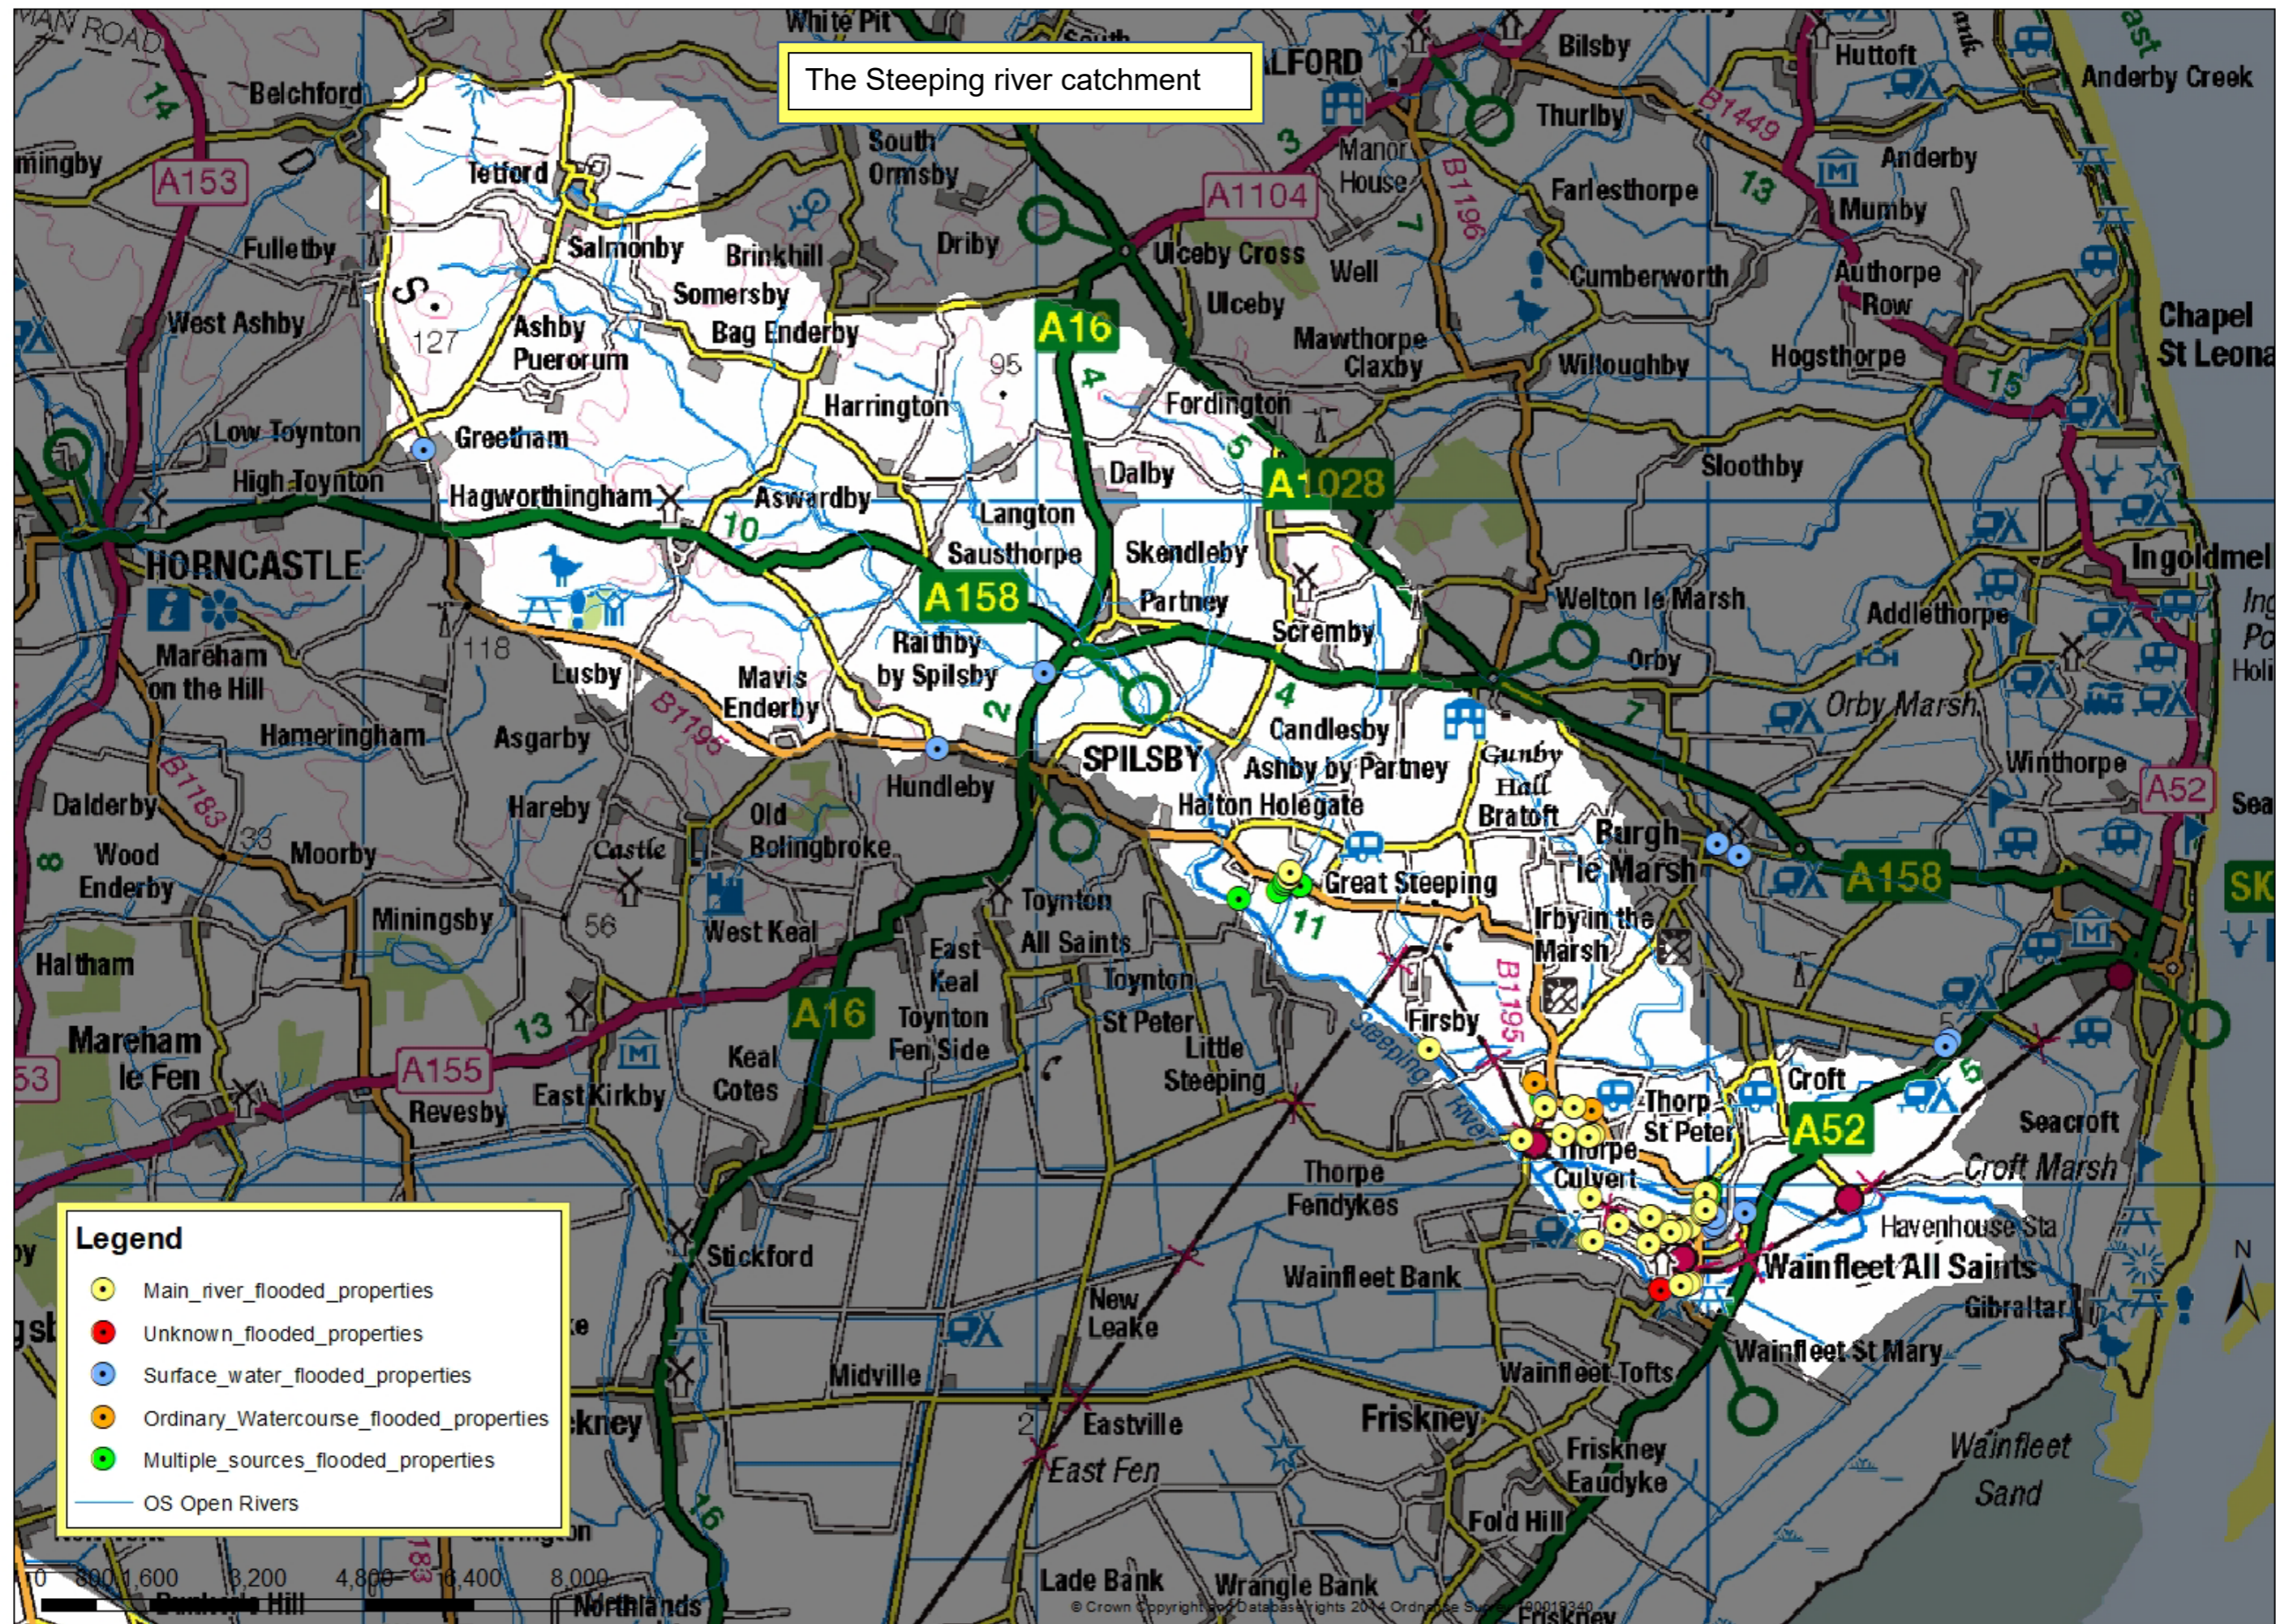
Figure 1: Internal Flooding Reports within the Steeping River Catchment

Within this catchment 88 incidents of internal flooding have been assessed as part of this investigation. These incidents are detailed in the Table 2 below and mapped on Figure 2. Details of the response to incident are also provided in the right hand column of Table 2.

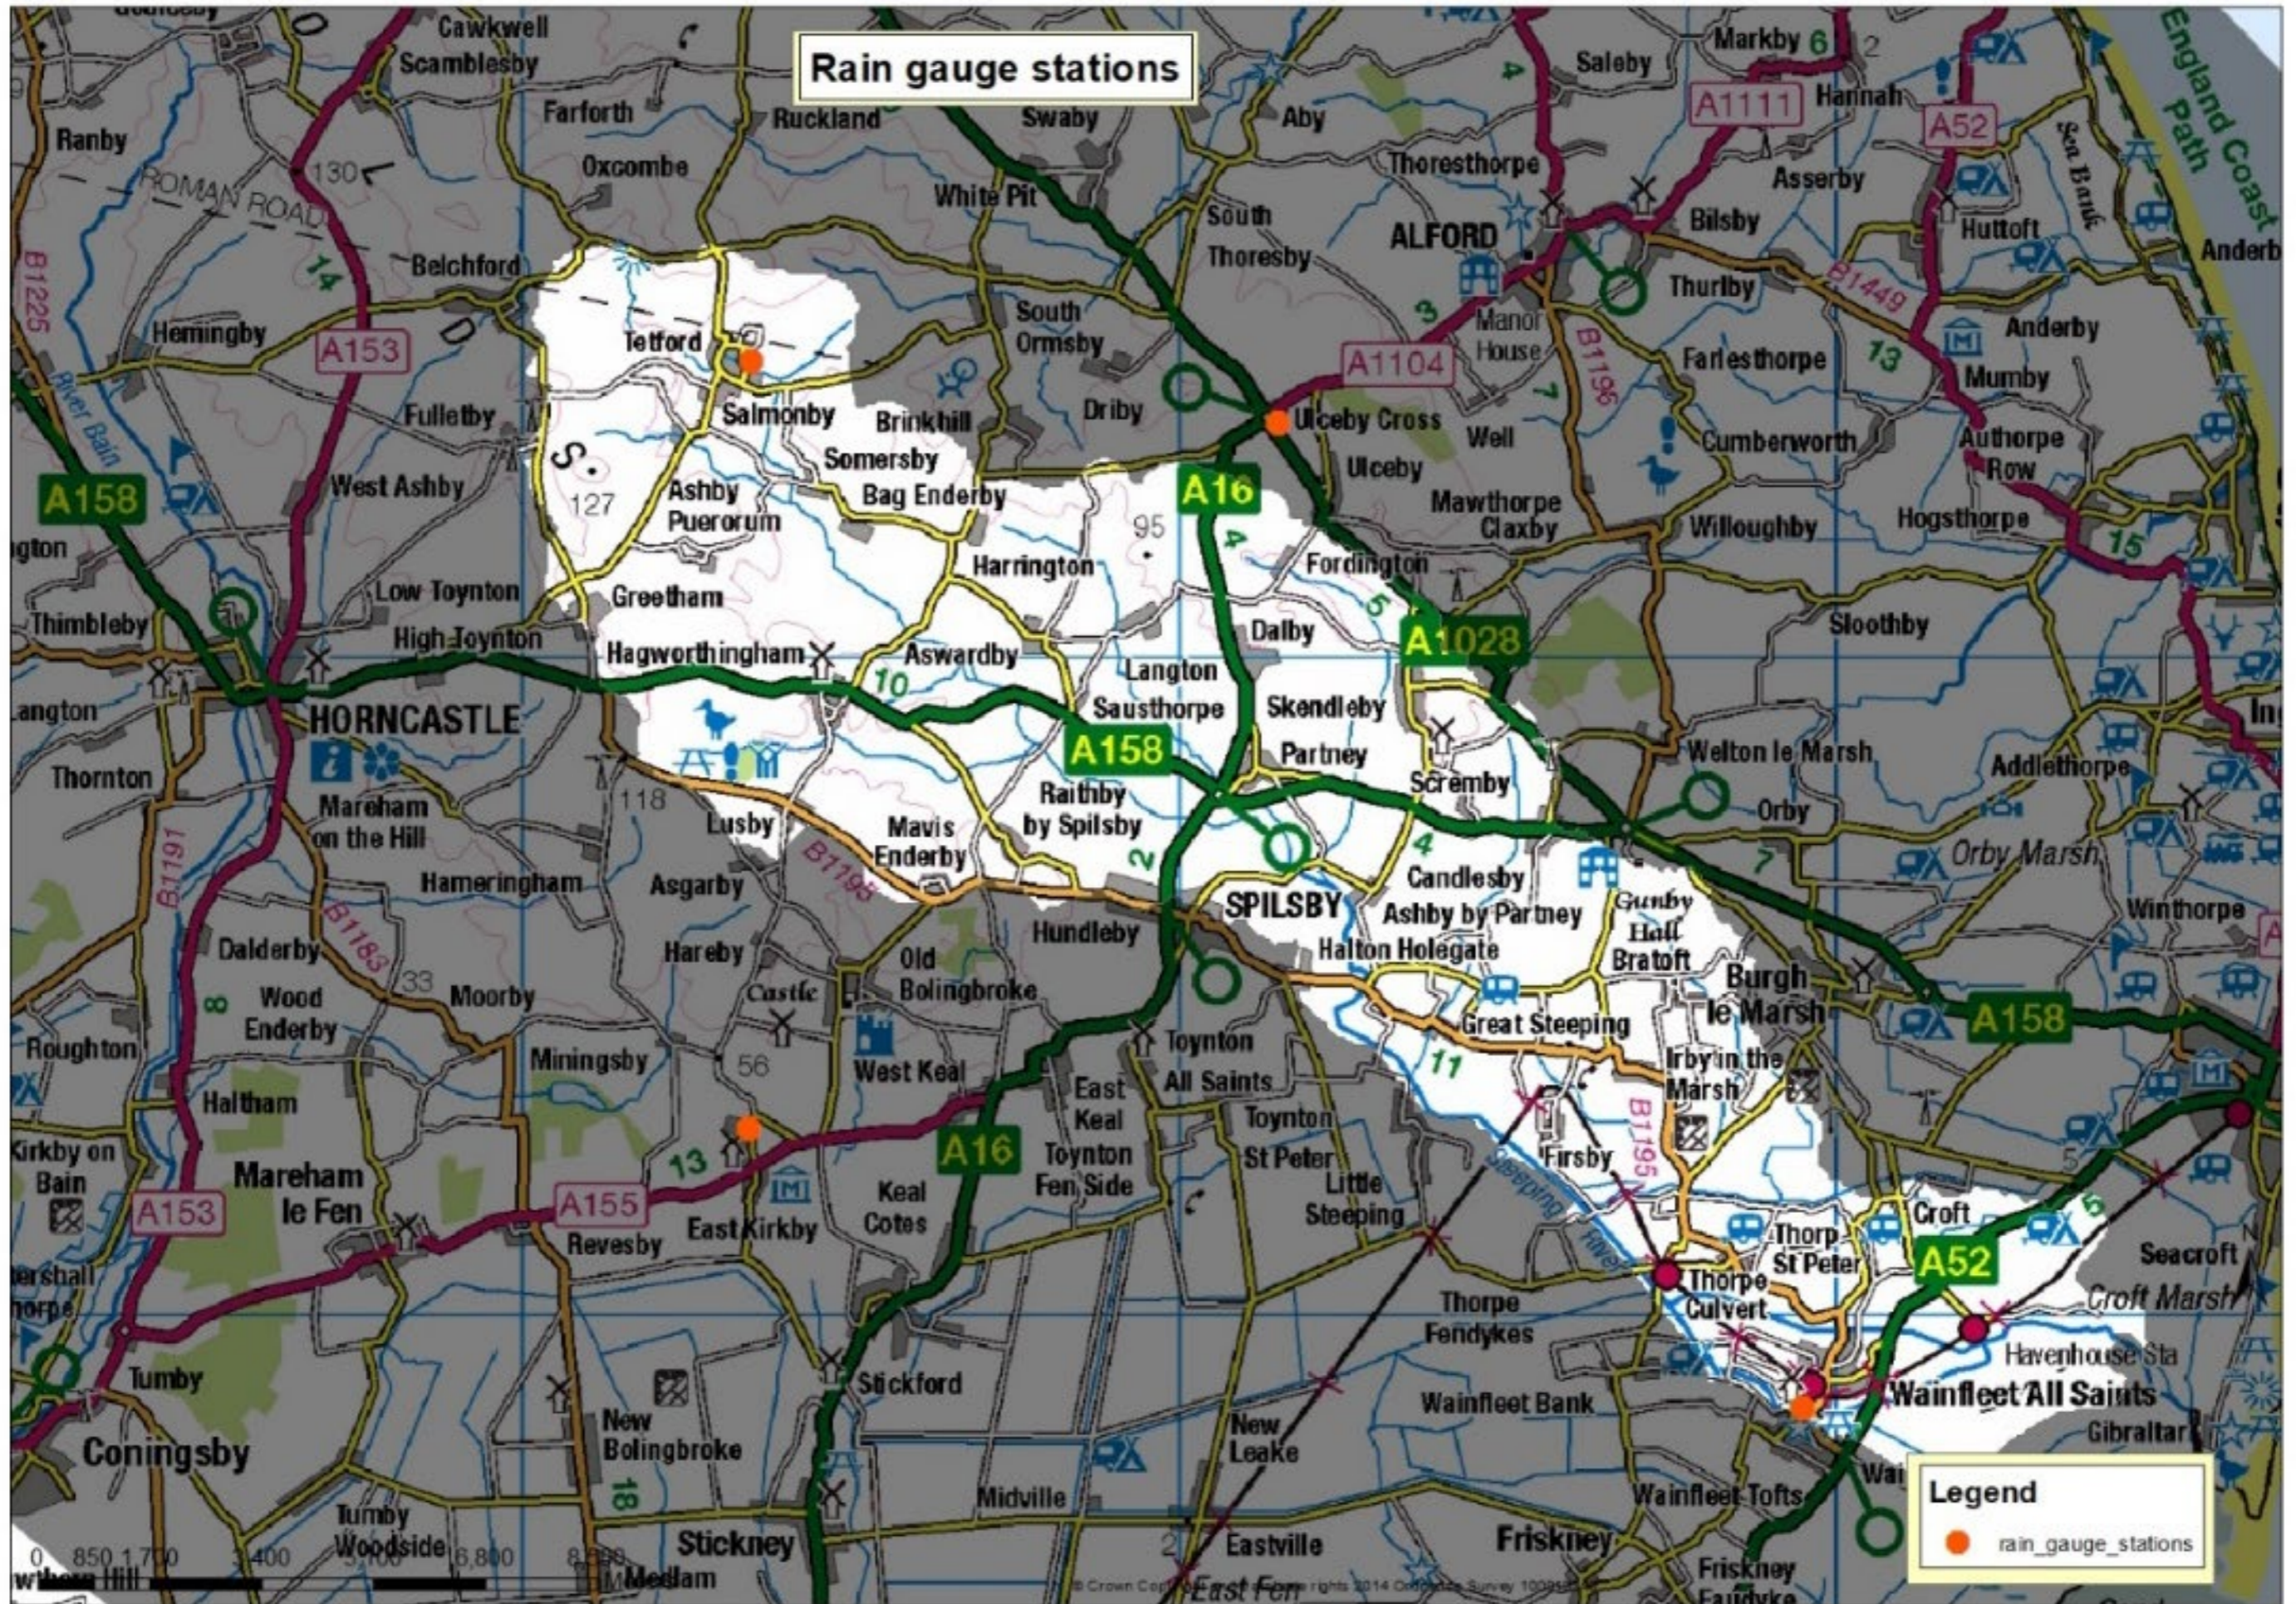
Figure 2: Rain Gauge Stations within the Steeping River Catchment

To examine the rainfall that influenced the flooding in June 2019, data was collected from four rain gauges within the region for the week 10th – 18th June. The location of these rain gauges are highlighted in Figure 2 and a summary of the total rainfall that fell and the event rarity are provided in Table 3. It is worth noting that two of the rain gauges fall outside of the Steeping catchment.

The event rarity varied across the gauging stations. Wainfleet saw the most intense rainfall followed by Ulceby Cross.

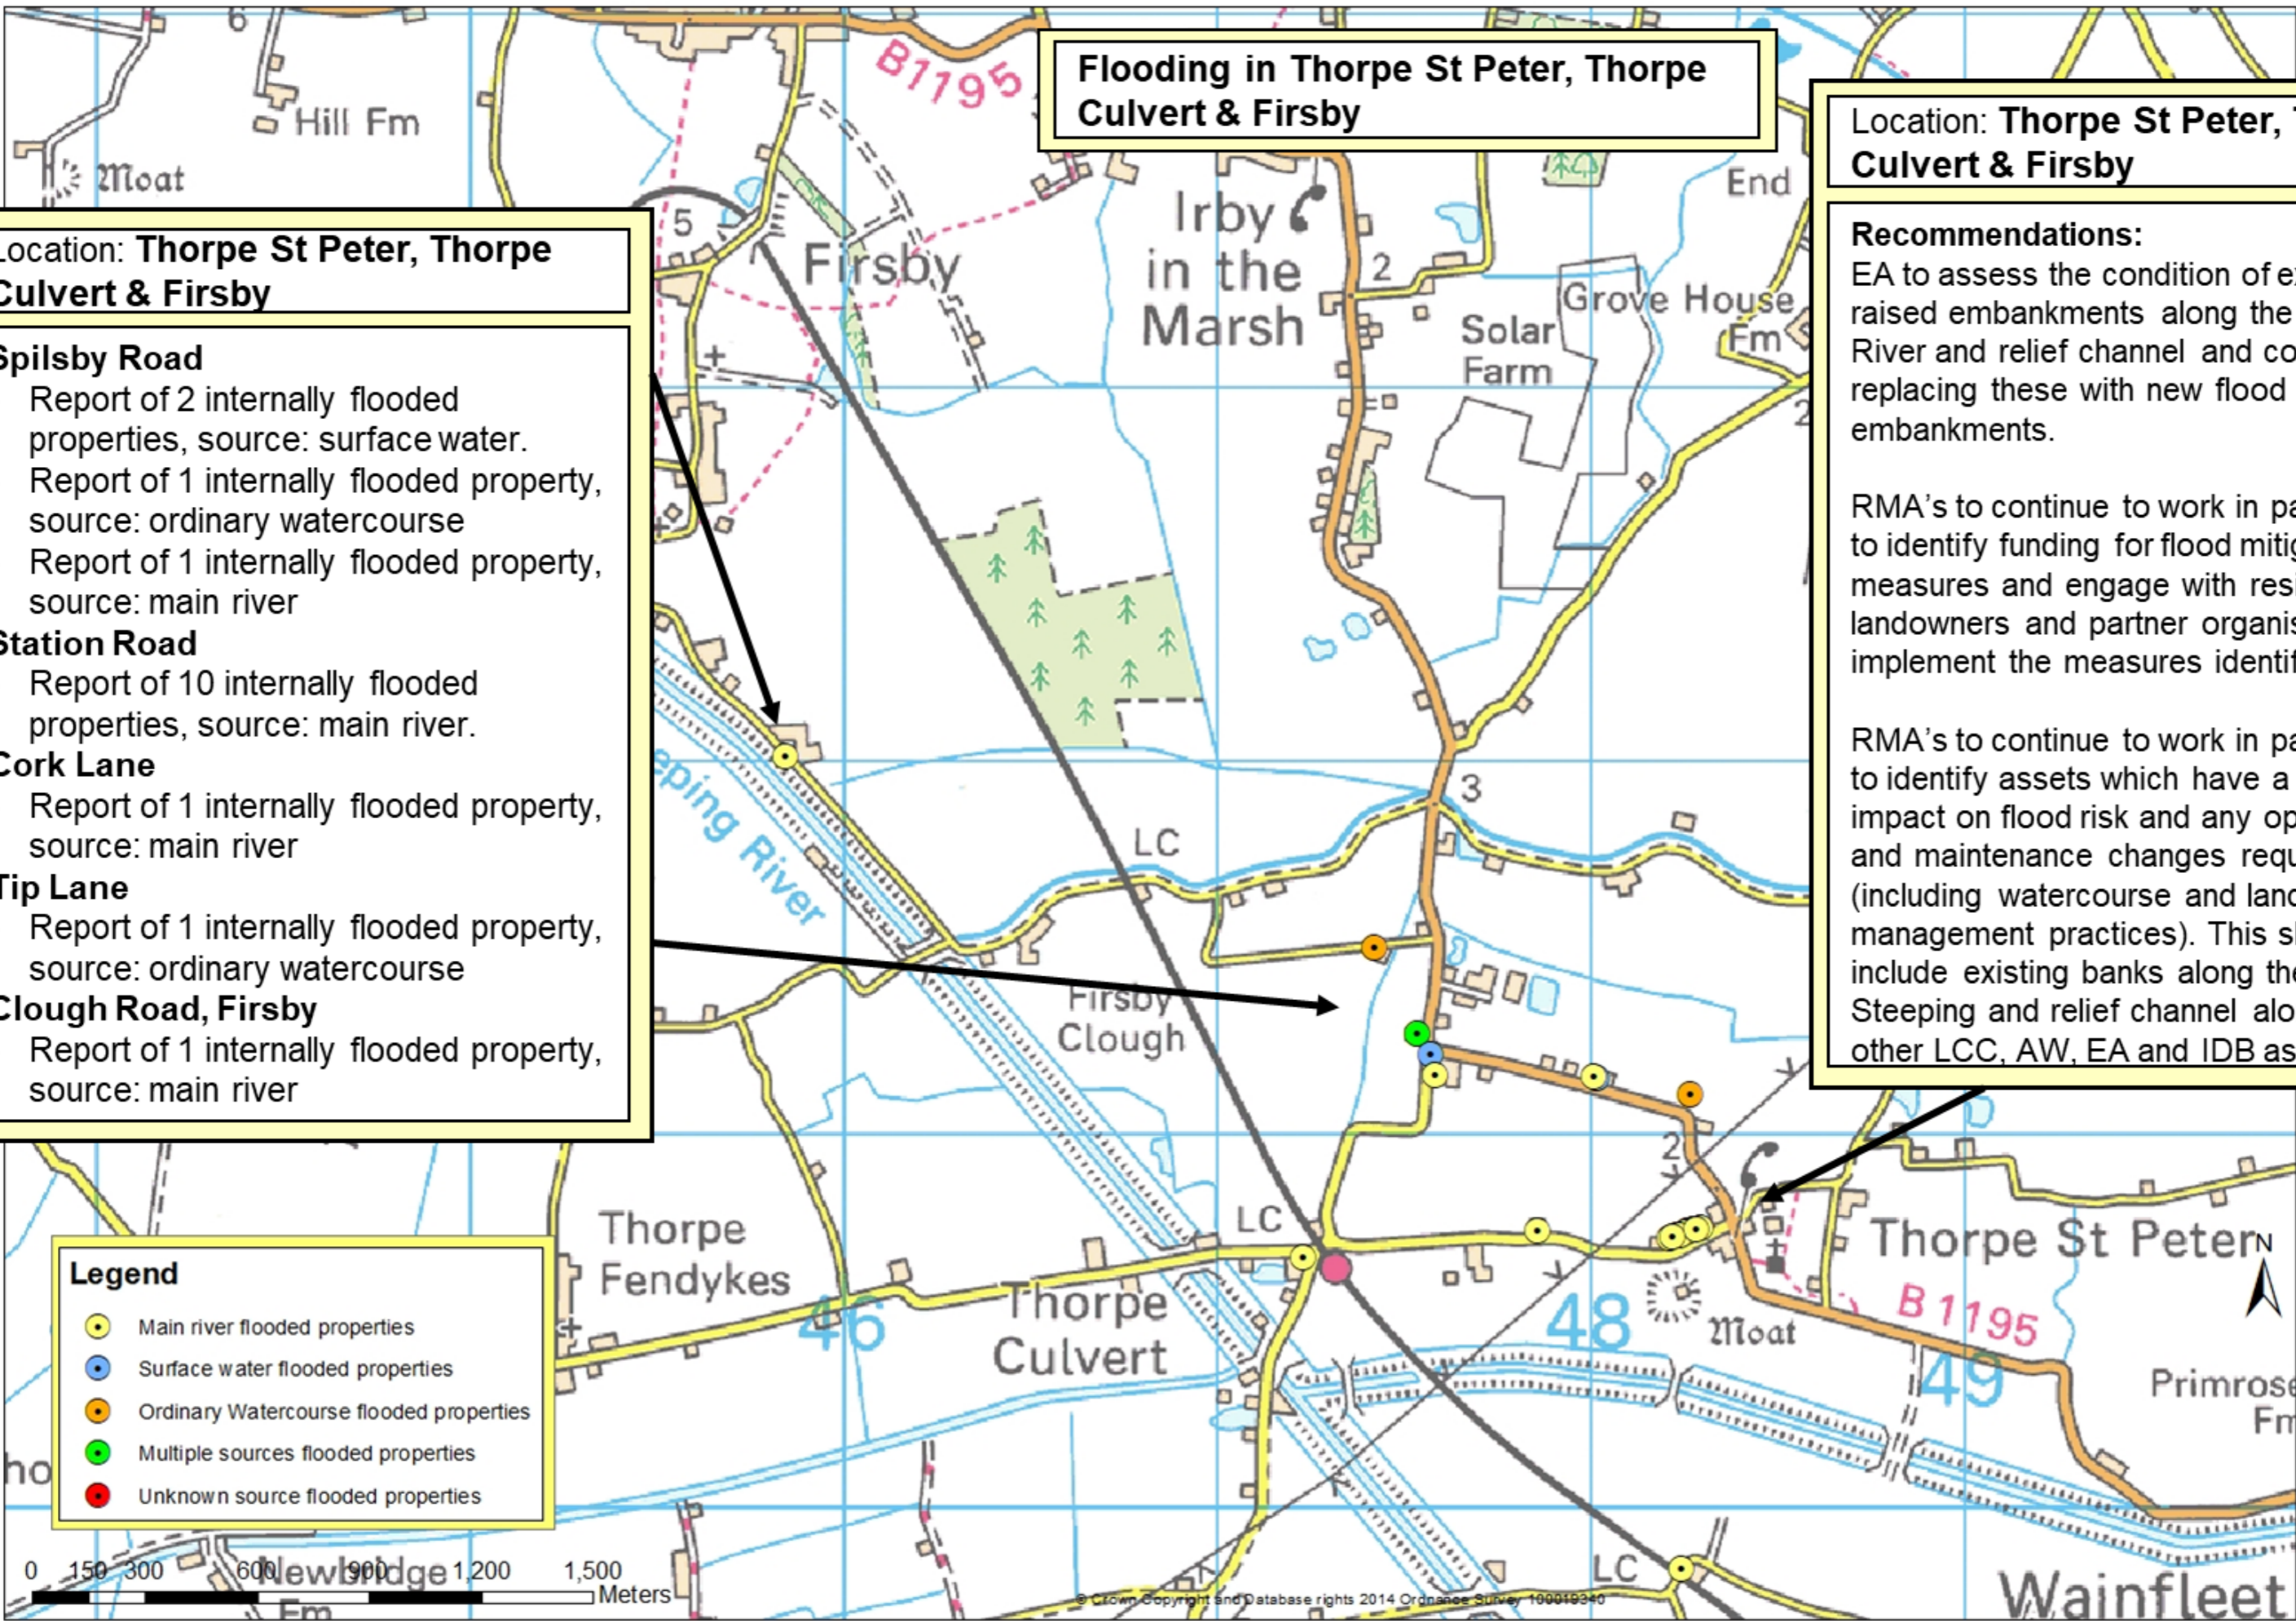
Flooding in Thorpe St Peter, Thorpe Culvert & Firsby

- Spilsby Road**
- Report of 2 internally flooded properties, source: surface water.
 - Report of 1 internally flooded property, source: ordinary watercourse
 - Report of 1 internally flooded property, source: main river
- Station Road**
- Report of 10 internally flooded properties, source: main river.
- Cork Lane**
- Report of 1 internally flooded property, source: main river
- Tip Lane**
- Report of 1 internally flooded property, source: ordinary watercourse
- Clough Road, Firsby**
- Report of 1 internally flooded property, source: main river

EA to assess the condition of existing raised embankments along the Steeping River and relief channel and consider replacing these with new flood embankments.

RMA's to continue to work in partnership to identify funding for flood mitigation measures and engage with residents, landowners and partner organisations to implement the measures identified.

RMA's to continue to work in partnership to identify assets which have a significant impact on flood risk and any operation and maintenance changes required (including watercourse and land management practices). This should include existing banks along the River Steeping and relief channel along with other LCC, AW, EA and IDB assets.
